**3658 Williams St.**

## LBP Assessment Results

# Property ID # 2677 / 3658 Williams Street

SITE NAME: VASQUEZ BOULEVARD AND I-70

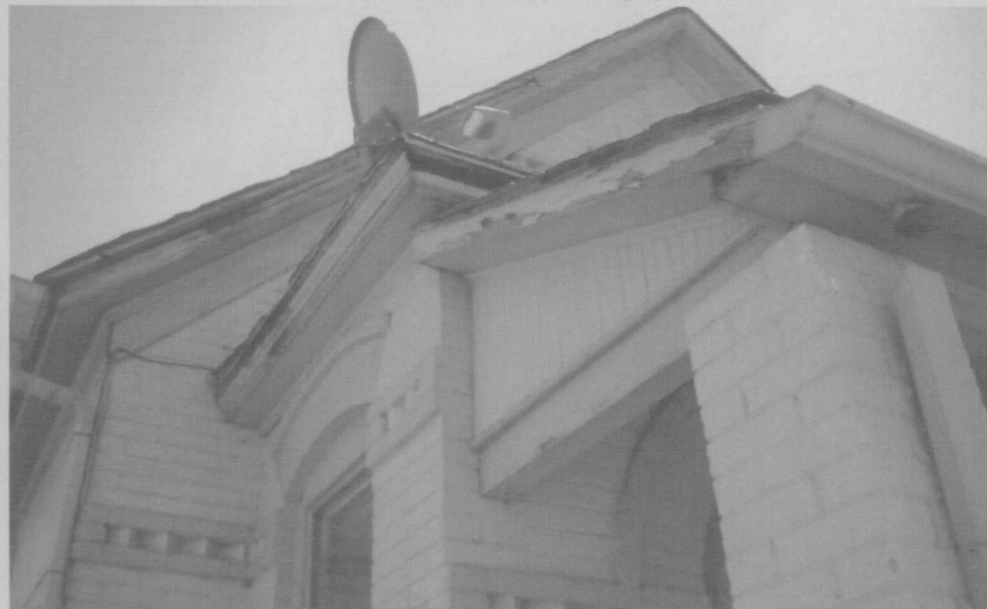
Wood soffit / trim on northeast corner of house contains peeling lead paint

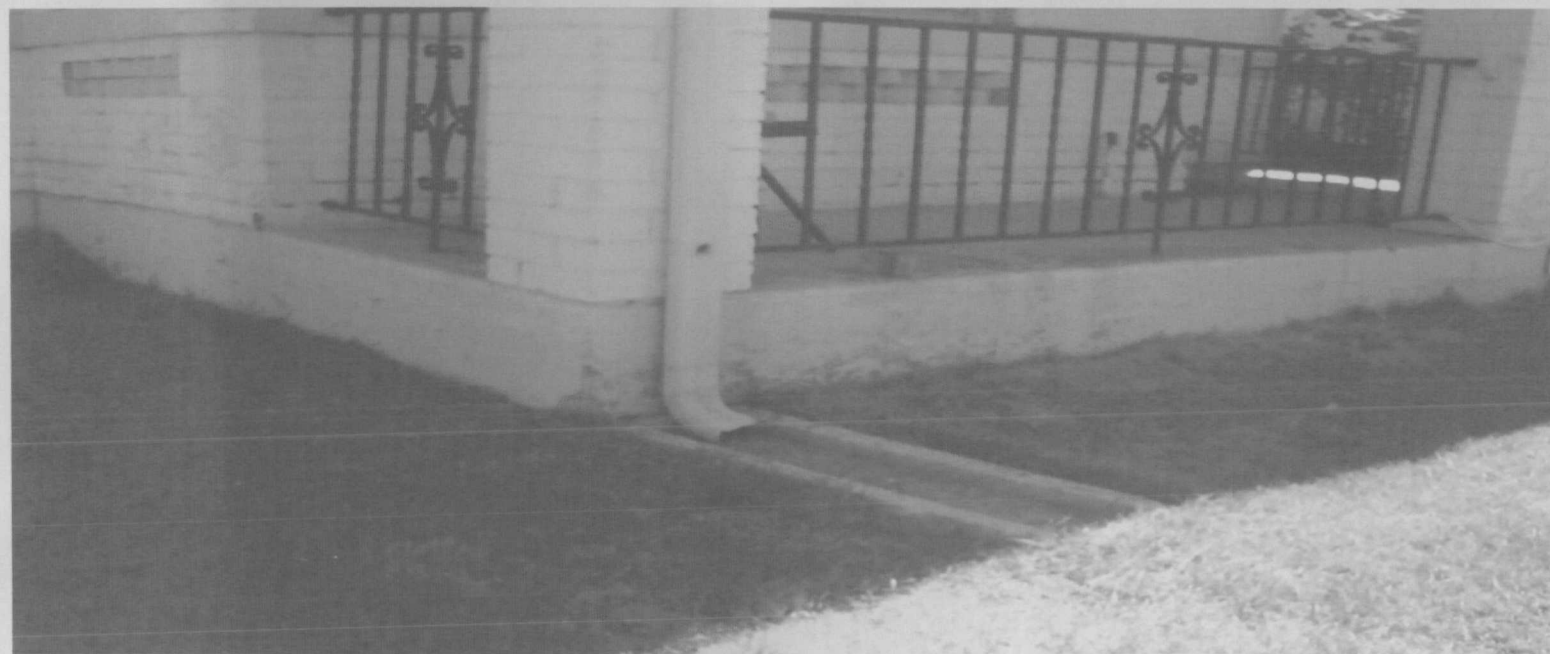
Cement porch foundation contains peeling lead paint

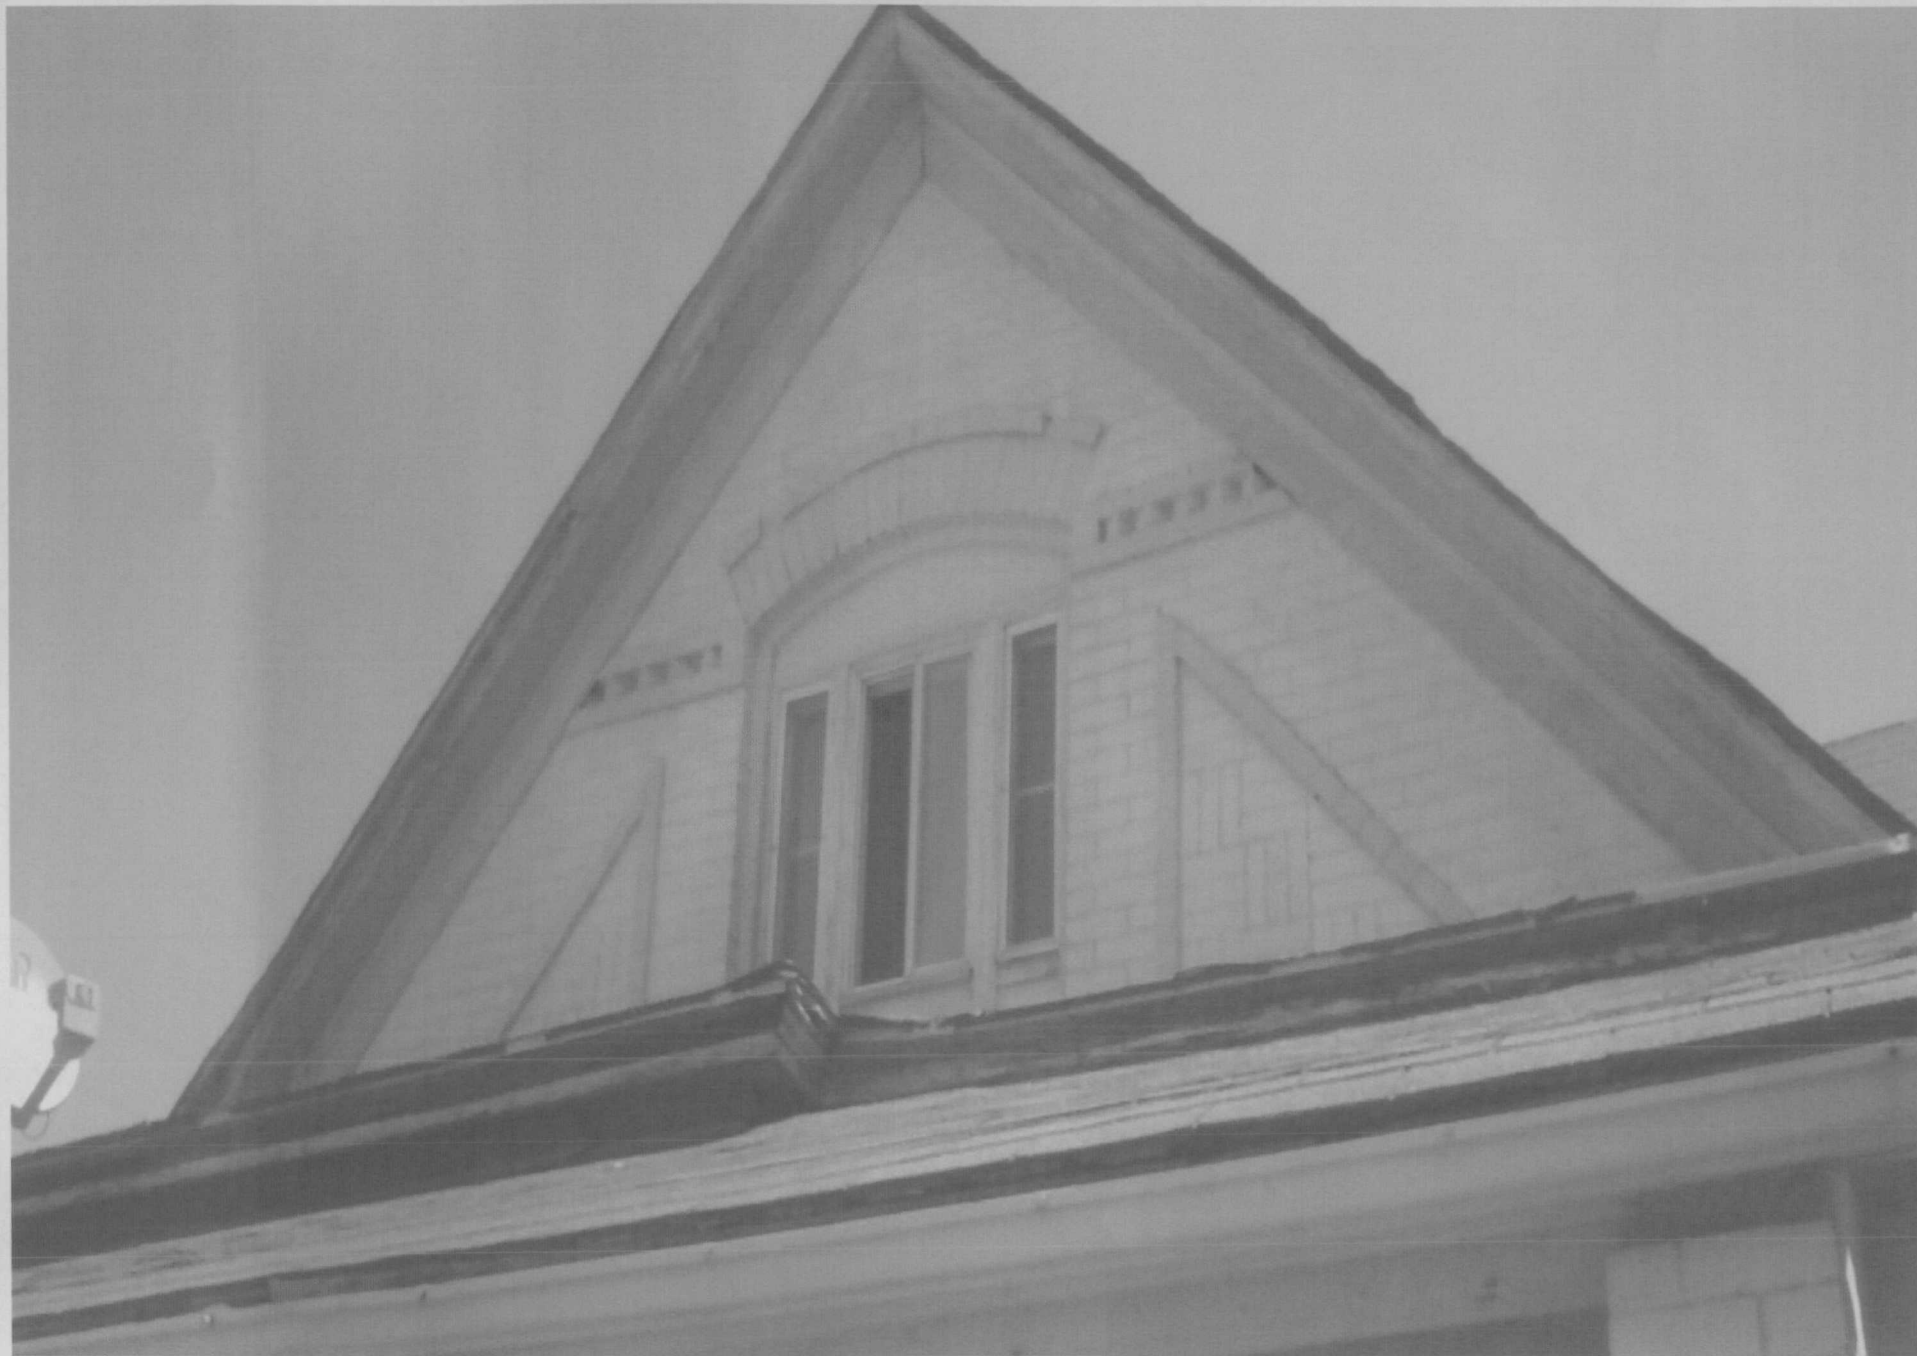
Property # 2677 : West trim / soffit contains peeling lead paint

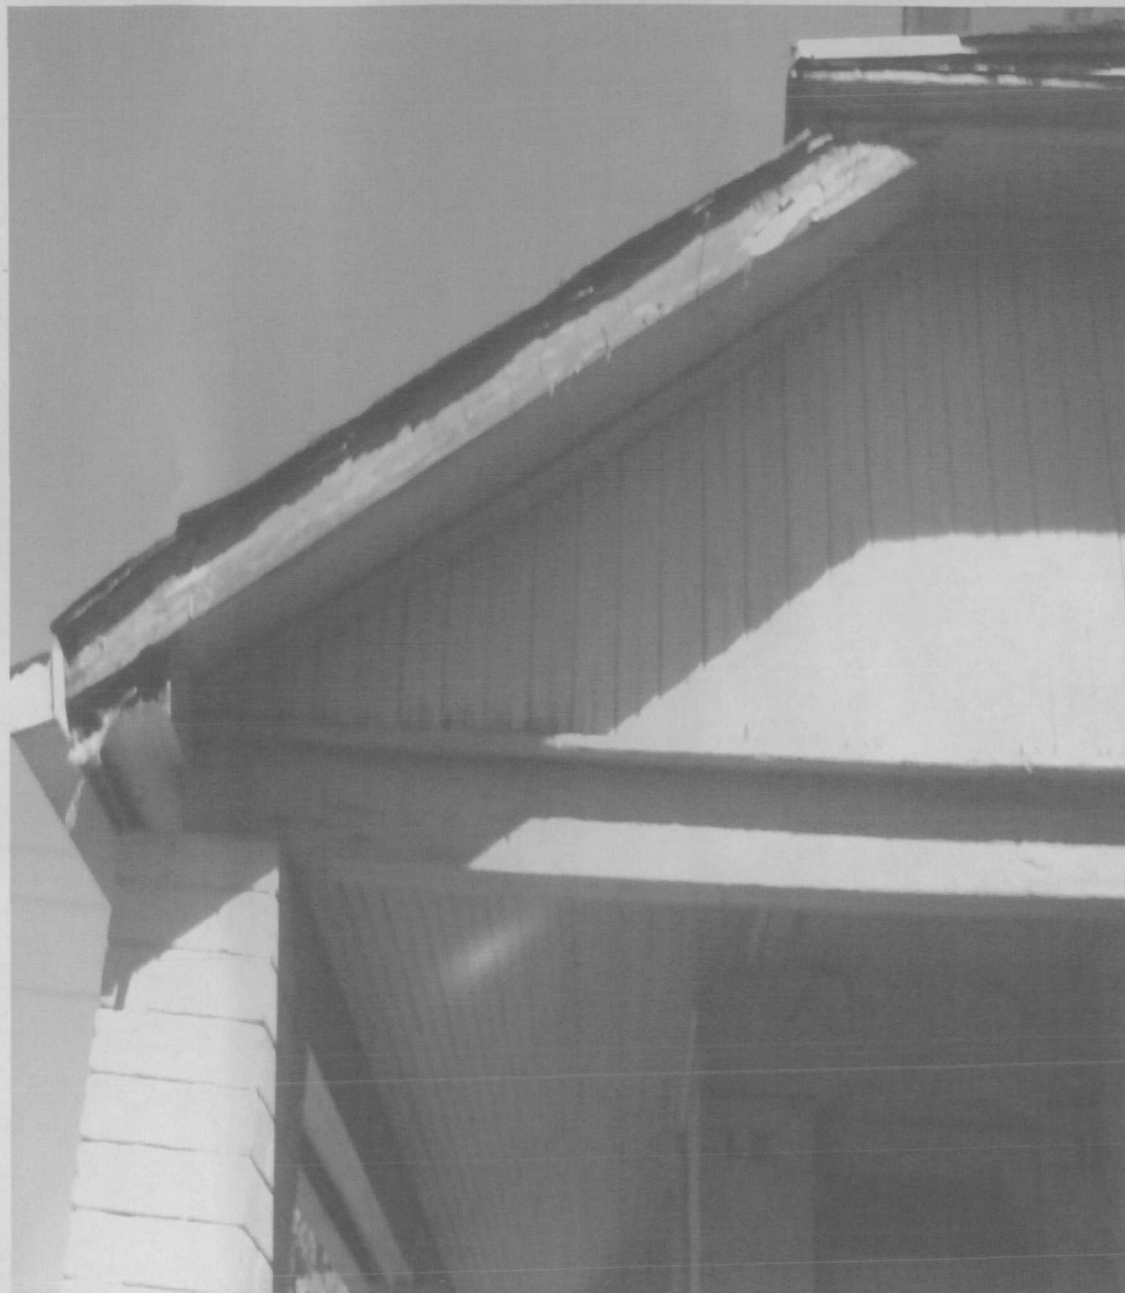
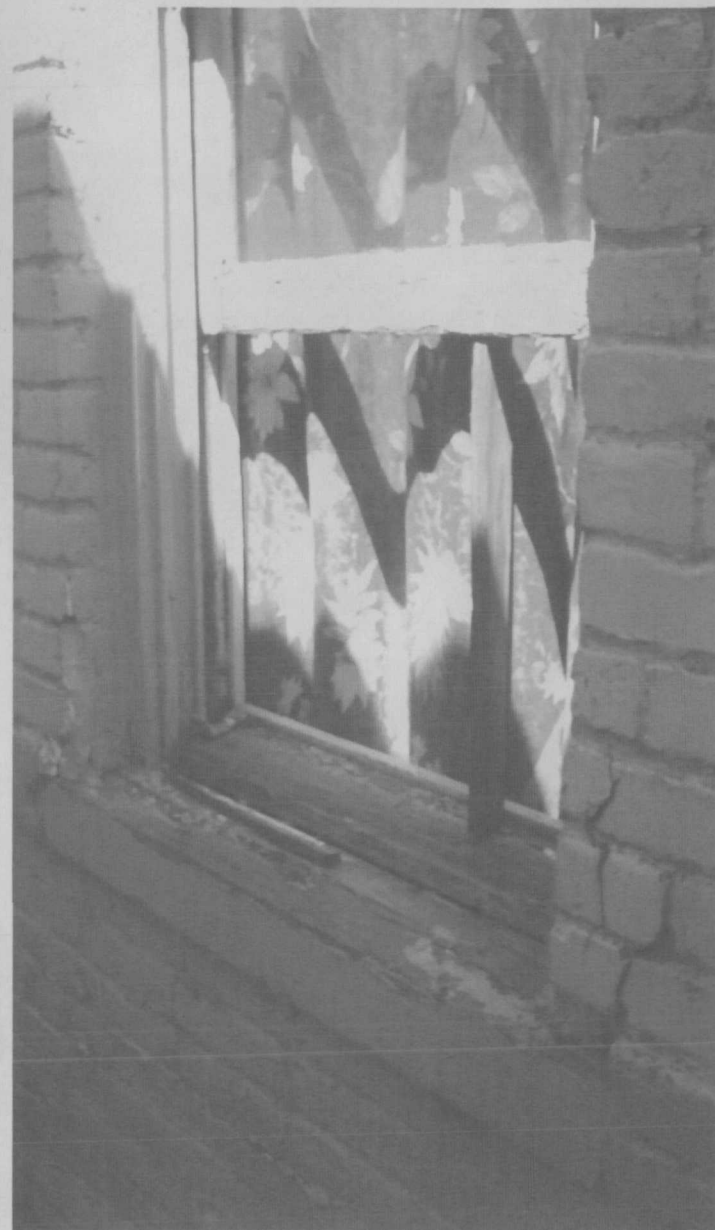
Property # 2677: Wood soffit / siding & window frames on south exposure contain peeling lead paint

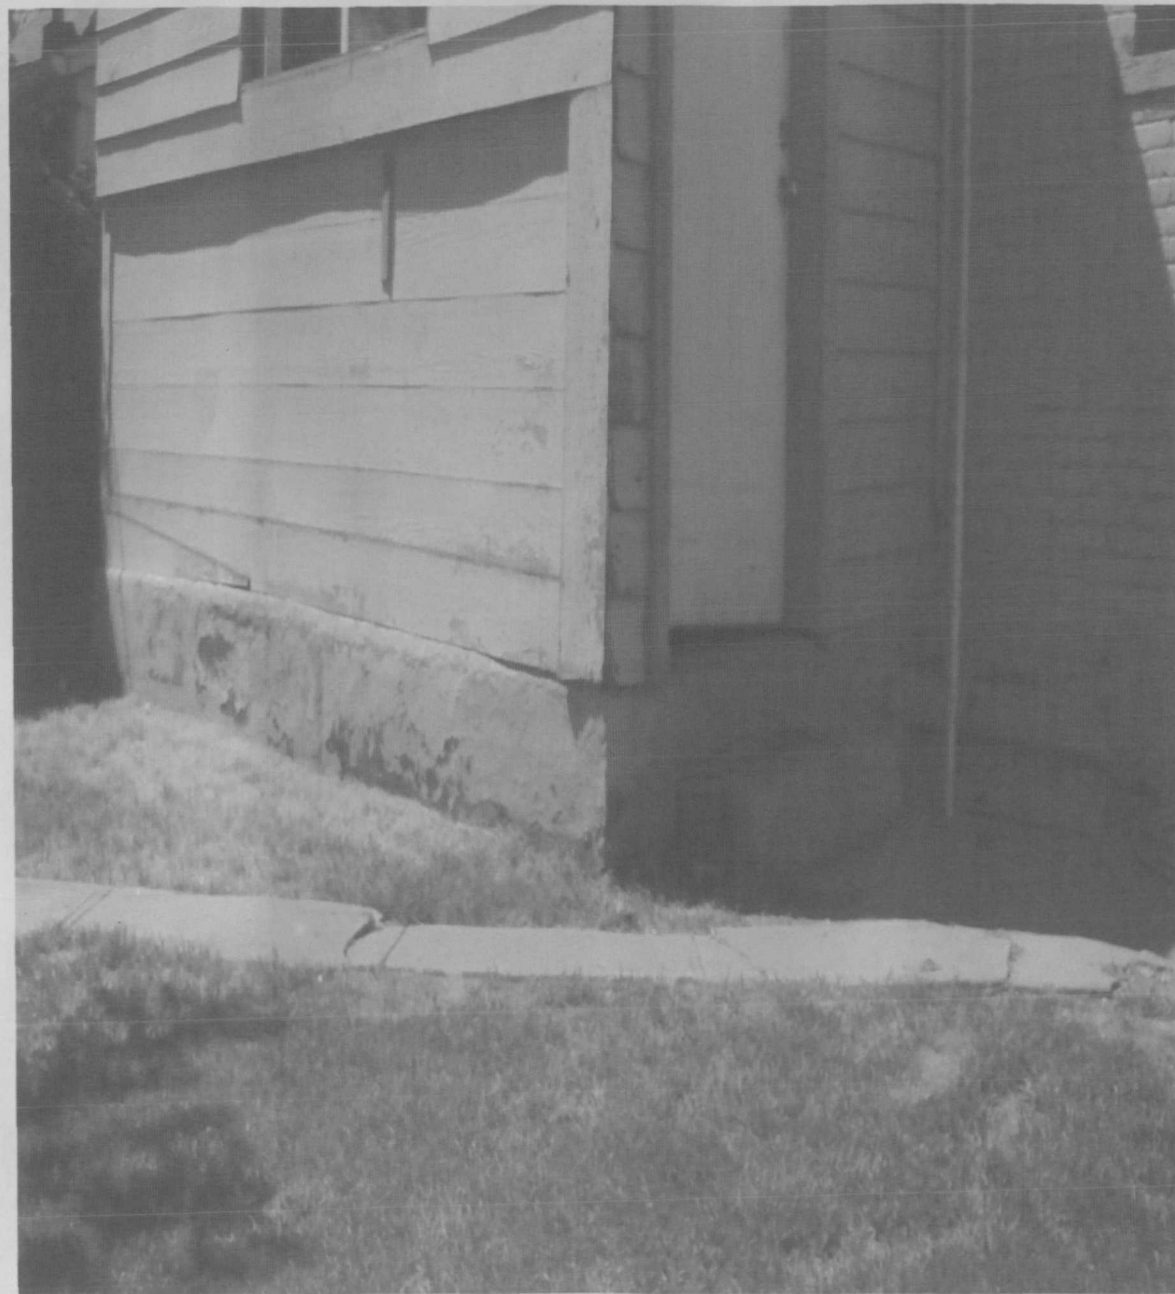
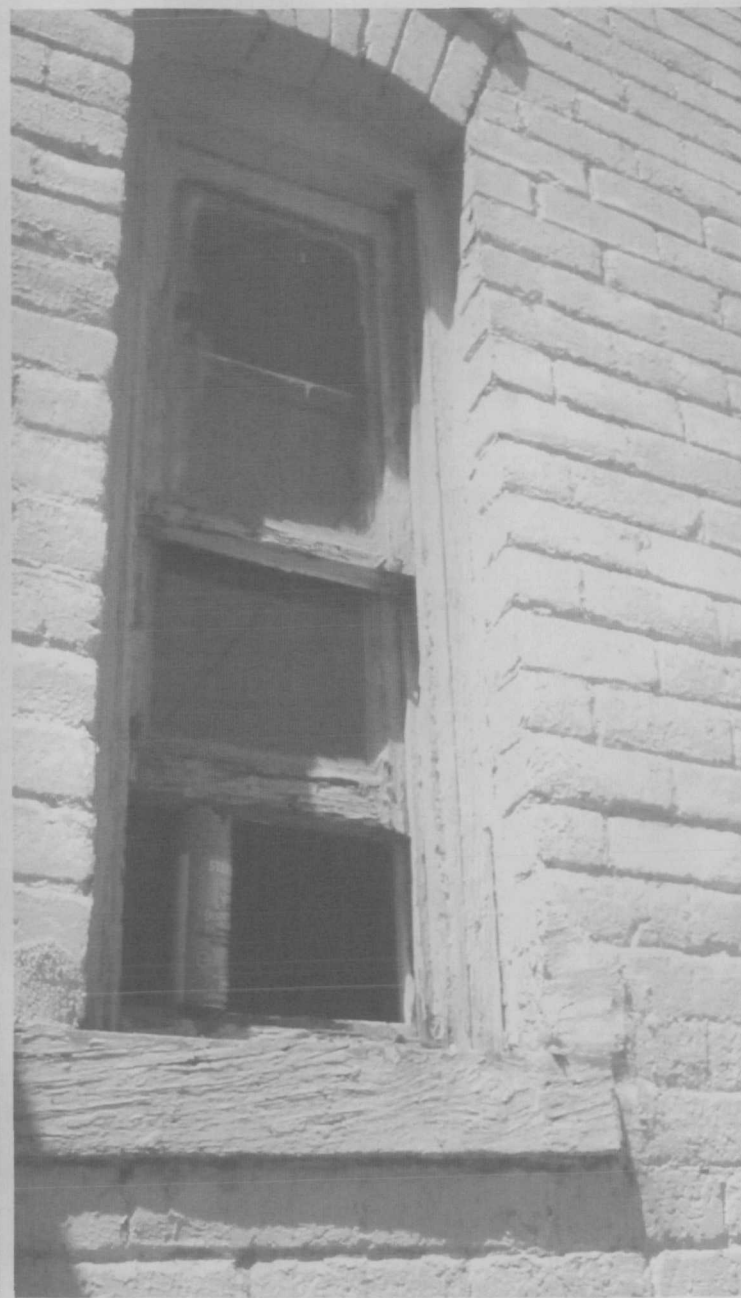
Property # 2677: Cement foundation & wood window frame on east exposure of house contain peeling lead paint

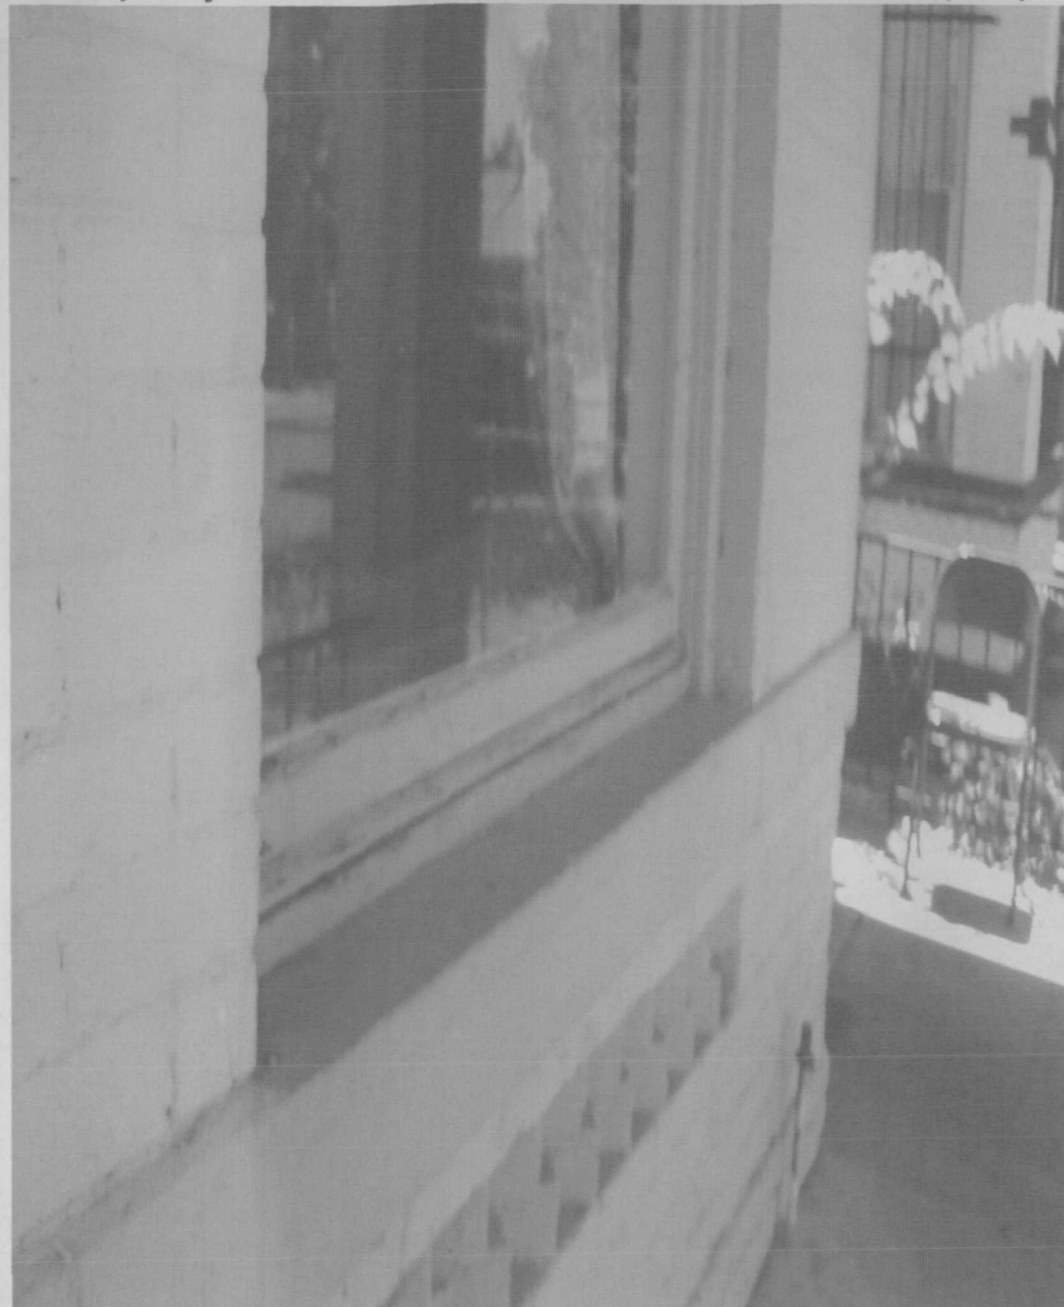
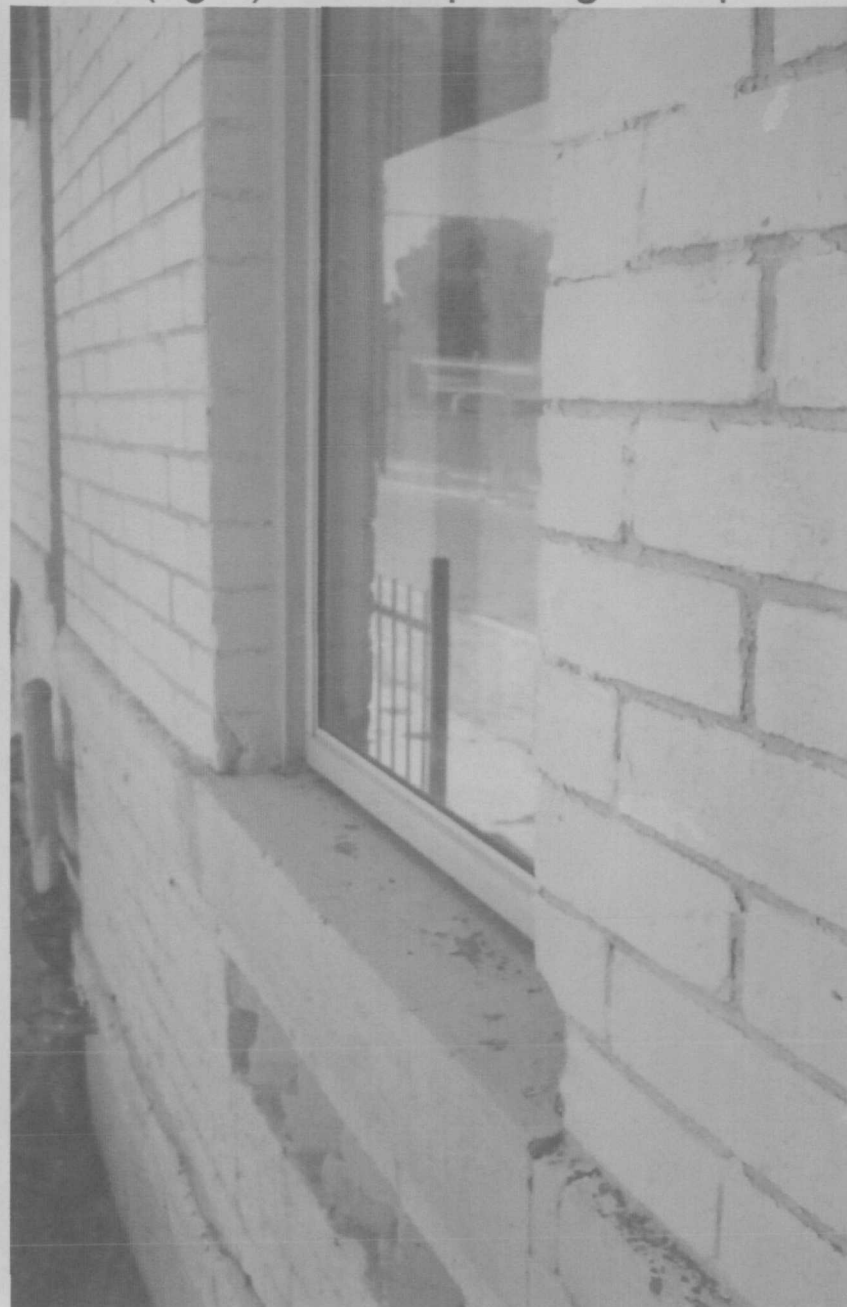
Property # 2677: Window frames on west (left) & north (right) contain peeling lead paint
